**PORT BURWELL AREA SECONDARY WATER SUPPLY SYSTEM  
JOINT BOARD OF MANAGEMENT**

**SUBJECT:** **PORT BURWELL AREA SECONDARY WATER SUPPLY SYSTEM - PIPELINE DESKTOP CONDITION ASSESSMENT REPORT**

RE: **Desktop Assessment of the Port Burwell Area Secondary Water Supply System**

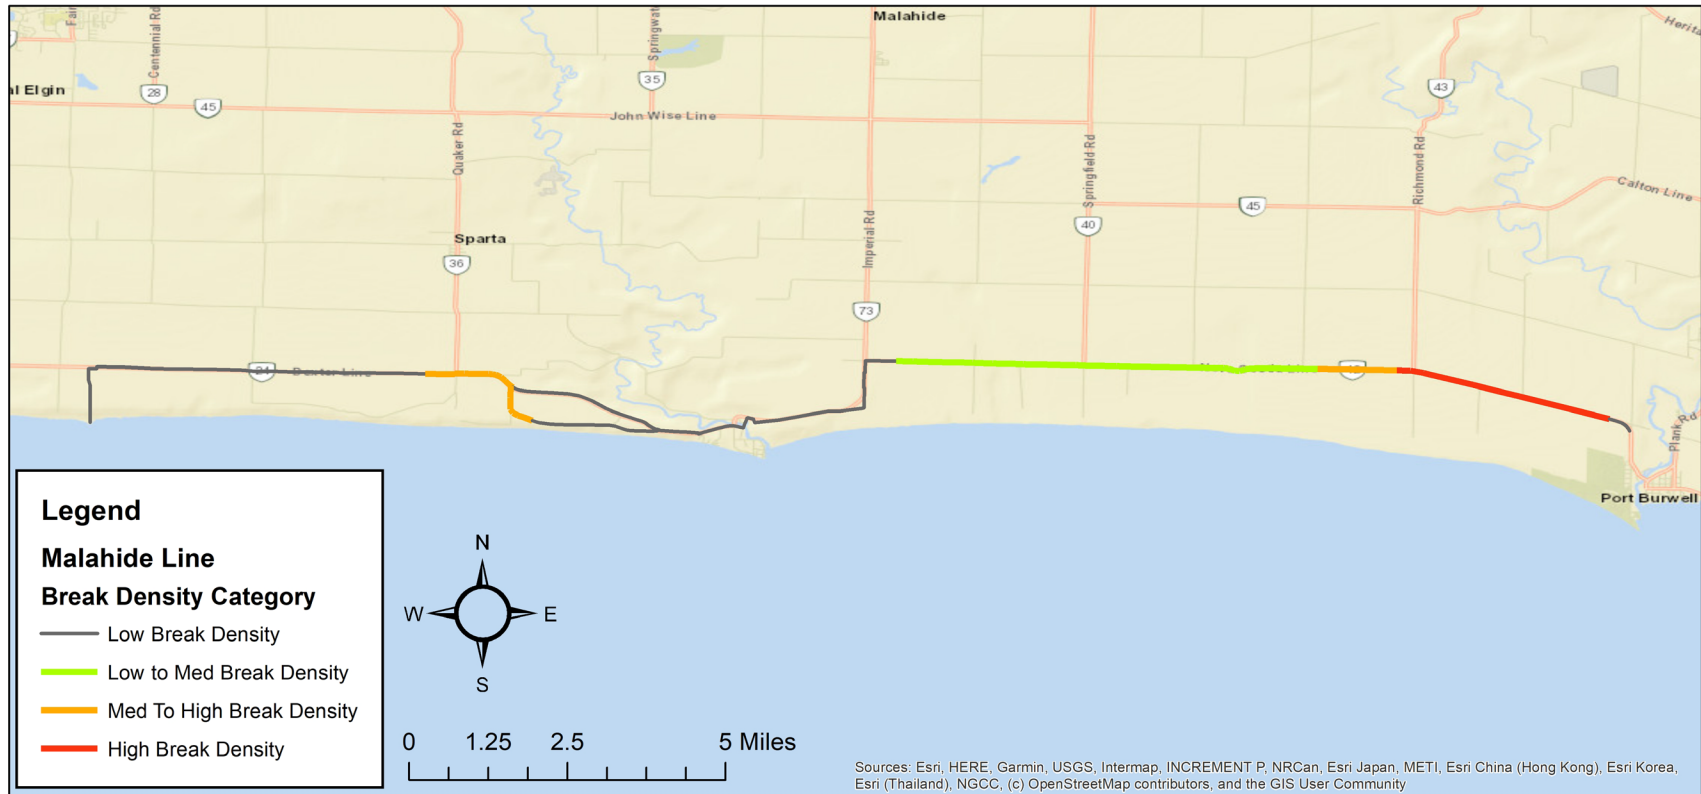
Figure 2.1: Overview of Break Density on the Port Burwell Area Secondary Water System

Figure 2.1 shows a spatial analysis of the recorded breaks on the transmission main, highlighting the high concentration of breaks on the PVC section at the eastern extent of the transmission main.

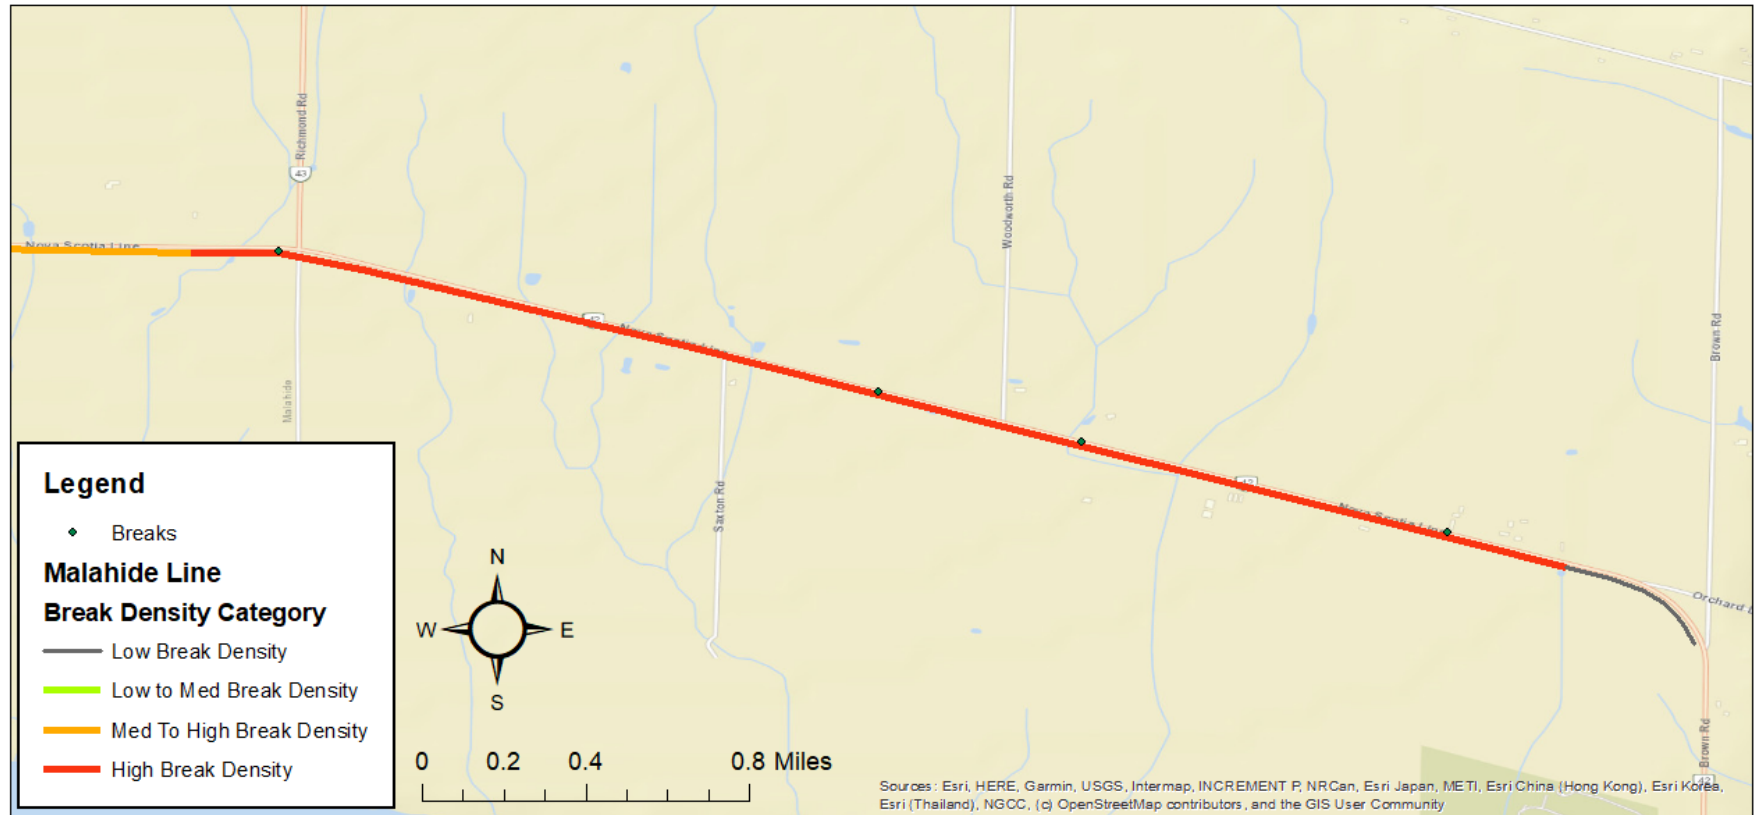
Figure 2.2: Transmission Main Breaks on the PVC Section of the Port Burwell Area Secondary Water System

Since 2013, the PVC section of the Port Burwell Transmission Main has experienced 11 recorded breaks. This equates to a breakage rate of 0.15 breaks per kilometre per year, or approximately 1 break per year. While a breakage rate of this magnitude may be acceptable on similar sized distribution networks of large utilities, the Port Burwell Area Secondary Water System is a transmission main with no alternative water supply. Research has shown that small utilities have up to two times more main breaks than large utilities, as they are less funded, have fewer engineers for design, data analysis and to develop asset management practices (Folkman, 2018). Serving approximately 3,000 residents, the Port Burwell Transmission Main has a much higher ratio of kilometres per customer than that of larger utility transmission mains. This means that breaks in a utility such as Port Burwell have a greater overall impact on the community.

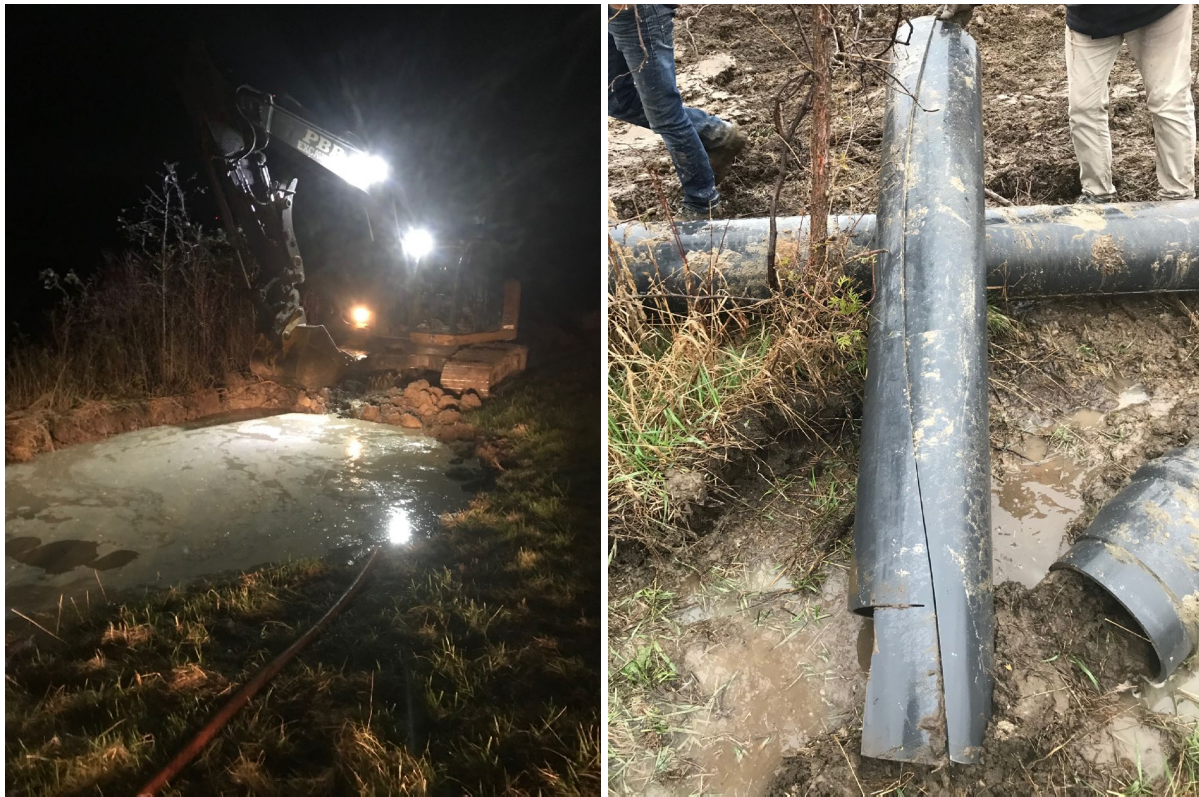
Figure 2.3: Main Break on the PVC Section of the Port Burwell Transmission Main

Figure 2.3 shows a main break which occurred in April of 2018, on the PVC section of the transmission Main. The type of crack shown on the right, is potentially a form of Rapid Crack Propagation (RCP), which is a large longitudinal crack, often spanning many metres in length, which cracks suddenly and causes extensive water loss, as seen on the left image. RCP is commonly caused by a sudden surge pressure, or water hammer. Records from the operation of the Port Burwell Transmission Main show that almost all breaks occurred after downstream hydrants were opened quickly for firefighting, causing pressure surges back through the system. The last four (4) breaks on the Main created points of entry for contaminants and were classified as Category 2 breaks (as classified in the field in reference to the MECP 2020 Watermain Disinfection Procedure), resulting in loss of pressure to downstream users and boil water advisories at the direction of the local Medical Officer of Health. This creates added public health risks to the community and risk to fire protection services.

Failures of this type can also be caused by improper installation, where the spigot end of one pipe is inserted too far into the bell end of the adjoining pipe. This type of installation error causes longitudinal cracking originating from the bell end of the pipe. Municipal Staff have expressed concern over the quality of the installation of the original pipe, noting that joints do not appear to be aligned properly in multiple locations. This, coupled with the knowledge of non-engineering bedding being used, suggests that the PVC failure issues may go beyond the pressure surges, and may be additionally caused by poor installation. A 2018 study showed

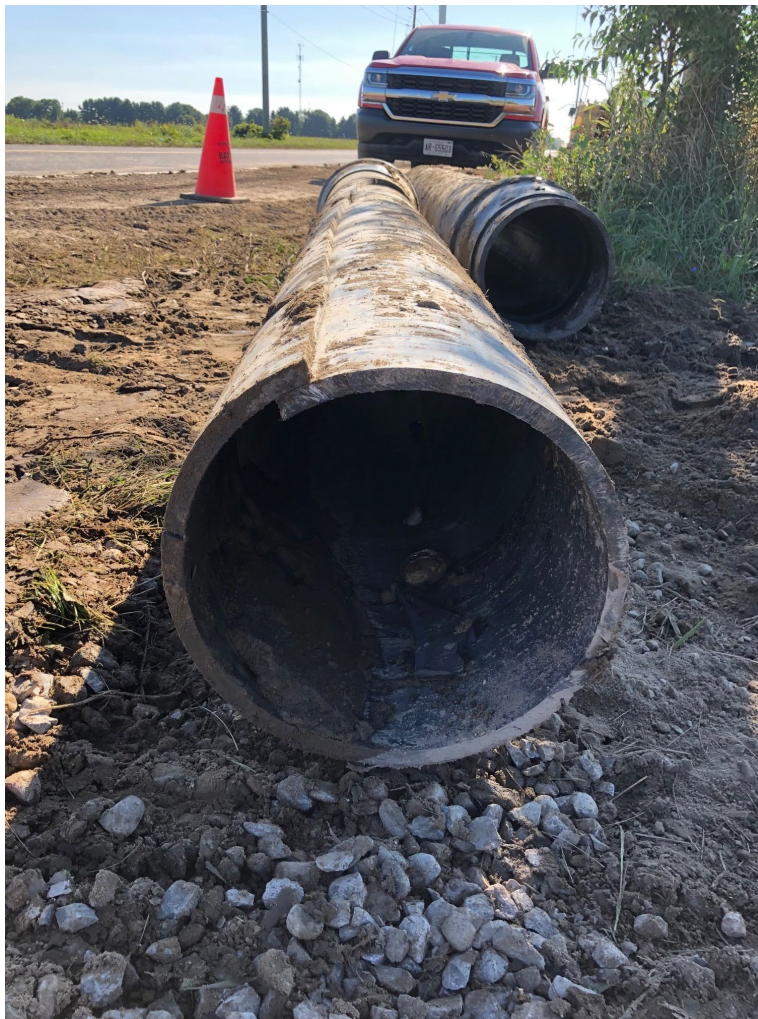
Figure 2.4: 2022 PVC Failure

Additionally, the manufacturing process of the PVC pipe can lead to pipes that are more susceptible to failure, especially with pressure surges. Figure 2.4 shows the 2022 pipe failure, where a longitudinal crack can be seen the length of the pipe, and the two fractured sections overlapping. This can be caused by issues during the manufacturing process of the pipe. PVC pipe is extruded through a circular die under high pressure, where the plastic fuses together after flowing through the die. This process can sometimes lead to weak fusion of the pipe material, causing pre-mature failure. When this happens, the curling of the two fractured sections shown in Figure 2.4 occurs due to high residual stress in the pipe wall. Pipes with high levels of residual stress are more likely to fail. Operations staff have noted that this type of failure has occurred on every PVC main break.

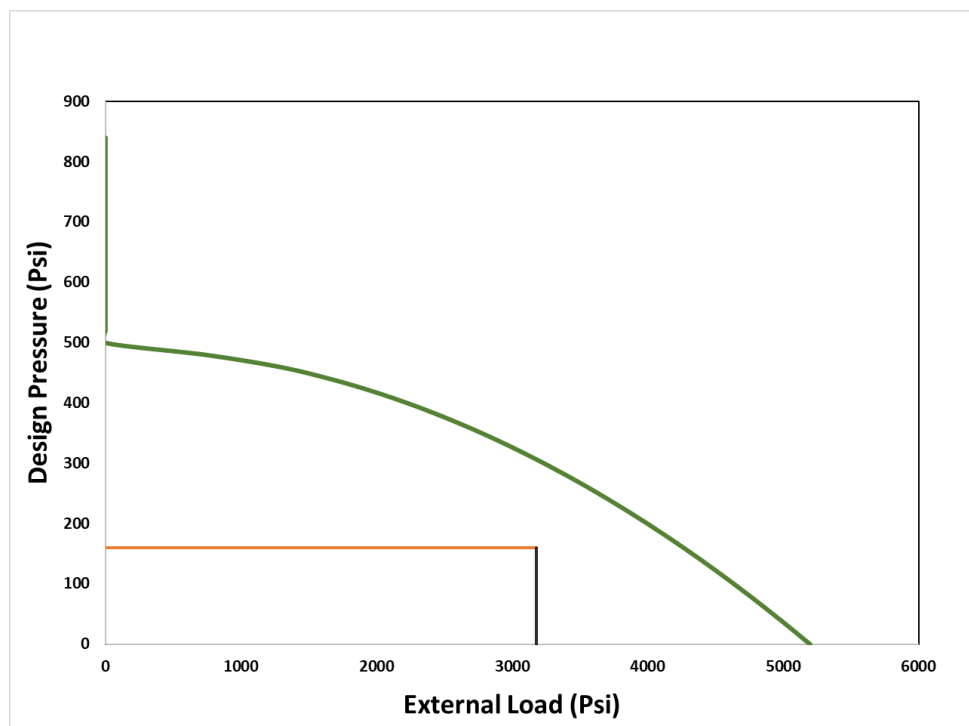
Figure 2.5: AWWA C401 Design Parabola for Asbestos Cement Pipe

Pure Technologies performed a design analysis of the asbestos cement pipe in the Port Burwell Transmission Main. Using pressure data obtained from the pressure monitoring and the Port Burwell SCADA system, the external loading and design pressure were calculated. The analysis uses data from the American Water Works Association C400-64 standard *"The Selection of Asbestos-Cement Distribution Pipe, 4 in. Through 16 in. for Water and Other Liquids"*, to determine the crushing strength and load coefficient of the 12-inch (300-millimetre) pipe.

The analysis uses a combined approach, where the combination of the design pressure and external load (orange and black lines respectively) must remain inside the green design curve. As seen in Figure 2.5, the design requirements for the Port Burwell AC pipe are satisfied for safe operation.

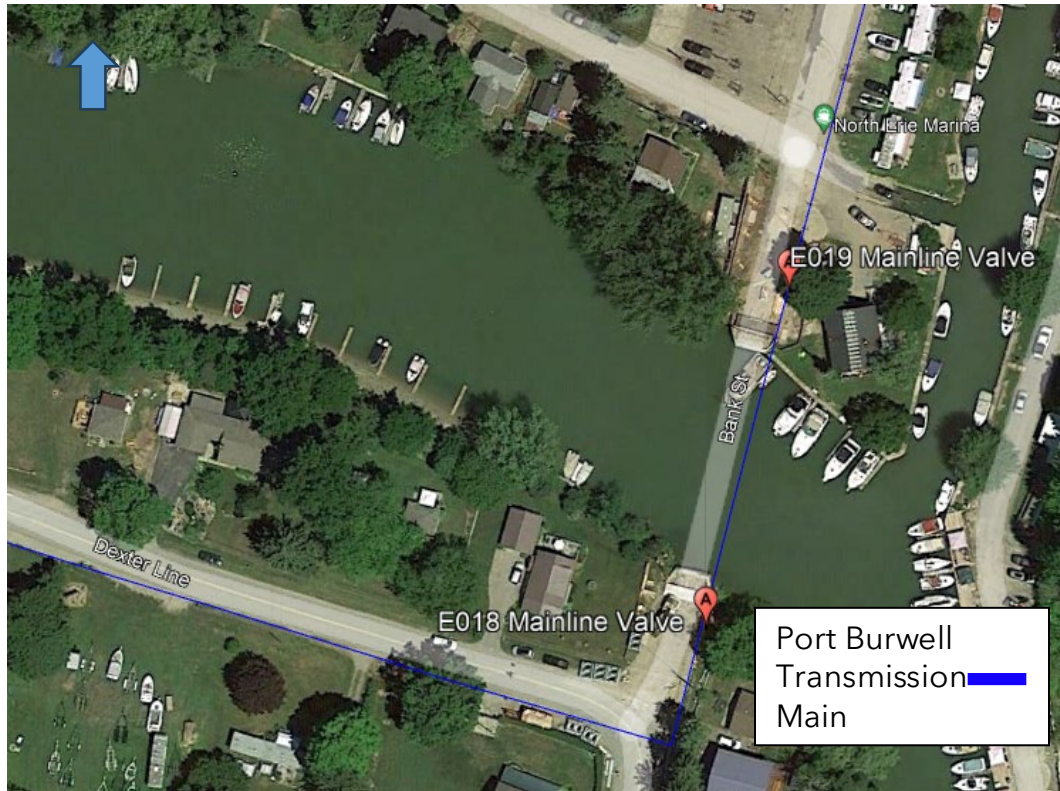
Figure 3.1: AC Section Crossing of Catfish Creek

that cross either of these environmental locations are assigned 3 points, and all others are assigned 1 point. As the AC section of the Port Burwell Transmission Main crosses Catfish Creek, as shown in Figure 3.1, it is assigned 3 points. The PVC section, while not crossing the same level of water, travels under multiple small creeks and watershed discharges into Lake Erie and is therefore also assigned 3 points.

- While the AC section of the transmission main has similar risk levels as the PVC section, it has seen less overall failure since installation. Although it is approaching 50 years of age, and will continue to degrade and corrode over time, the AWWA design analysis shows that the pipe is able to withstand the current internal and external loads due to low pressure. The Board should obtain an estimate to realign the Catfish Creek crossing to be supported by the Port Bruce Bridge, to reduce the environmental risk associated with the transmission main.

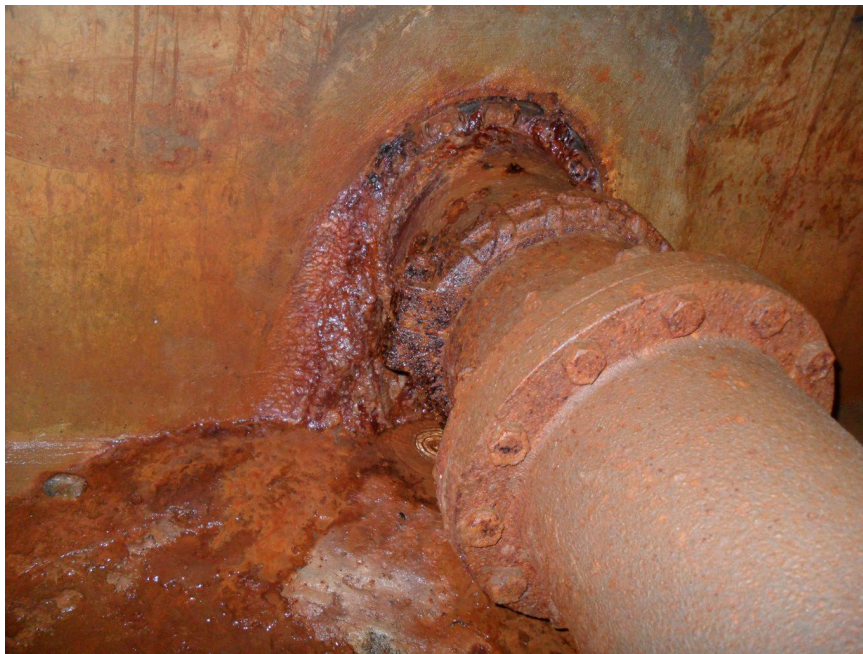
Figure 4.1: Poor Condition of Piping and Chamber E038 Prior to Remediation

- 2016 Water Main realignment along New Dexter Line - \$1,589,000.
- Water Tower Refurbishment - \$685,459.
- Chamber E038: Entire chamber replaced with new piping and flow metre - \$75,000. Previous chamber piping in poor condition shown in Figure 4.1.

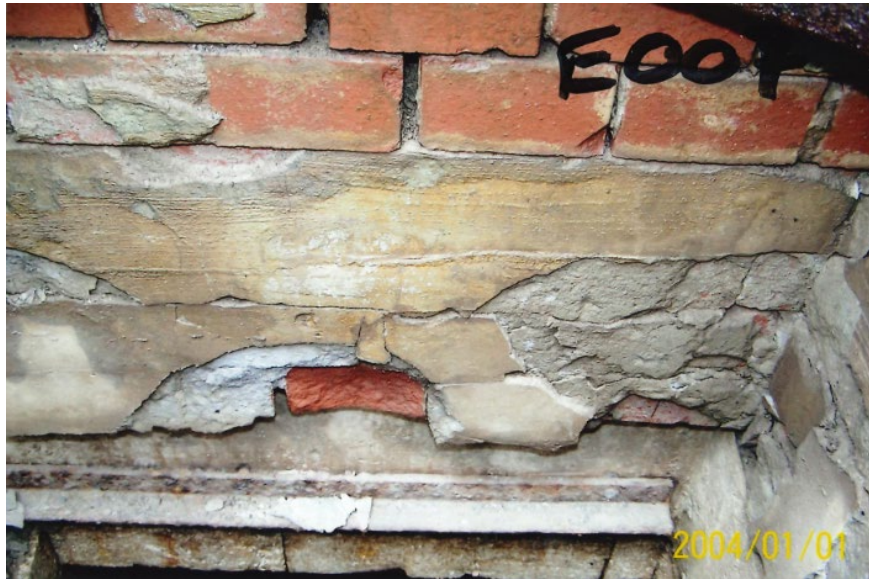
Figure 4.2: Poor Condition Chimney in Chamber E007

- Chamber E023: Replacement of chamber lid and chimney, valve replacement - \$15,000.
- Chamber E029: Replacement of chamber chimney and valve replacement - \$14,700.
- Chamber E027: Replacement of chamber chimney and valve replacement - \$13,000.
- Chamber E007: Chamber chimney replacement - \$11,200. Poor condition chimney prior to repair shown in Figure 4.2.

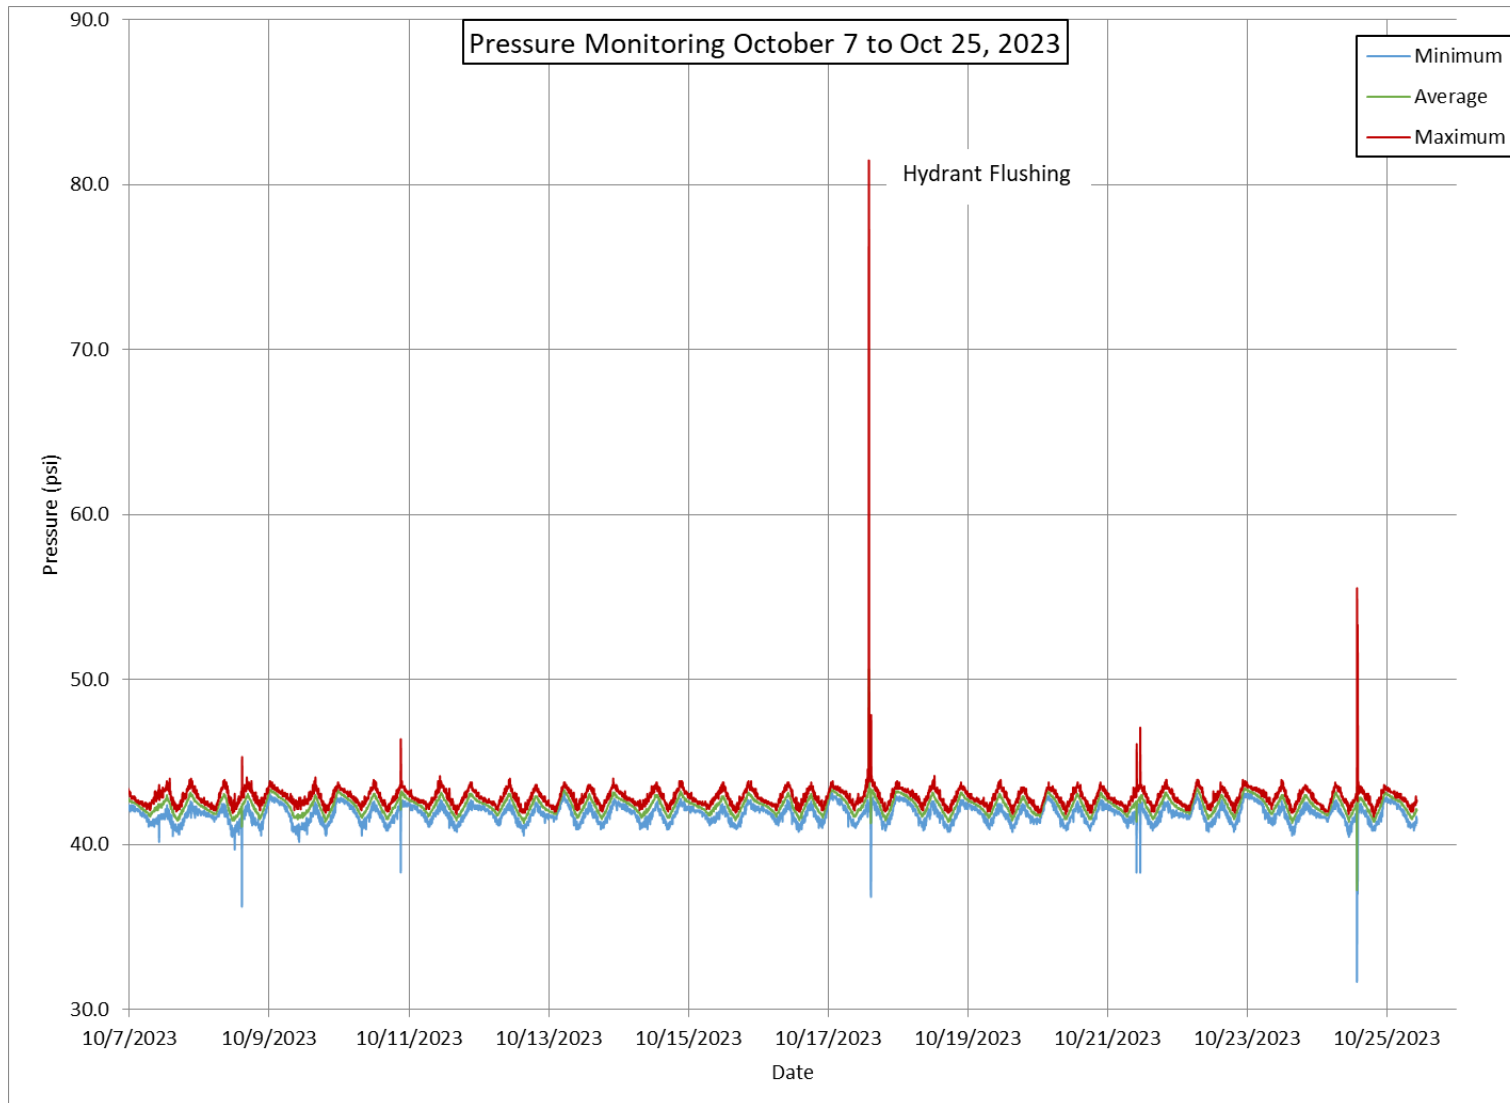
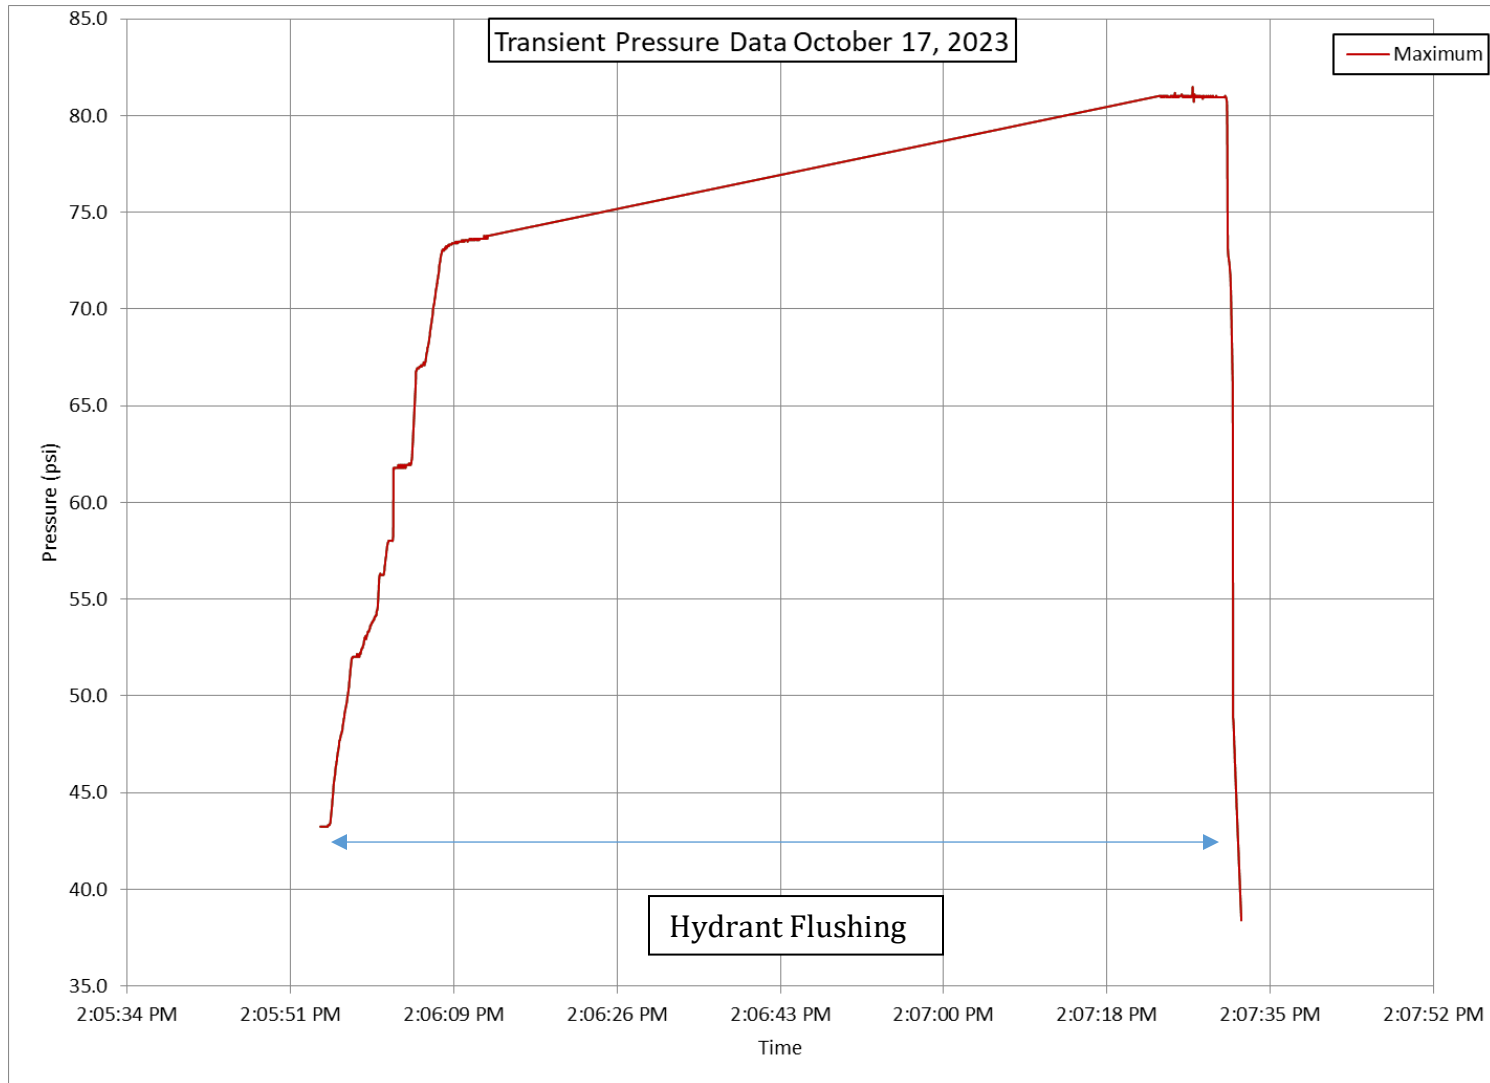
## APPENDIX A: Pressure Monitoring

- *Pressure surges*: As part of the assessment, Pure Technologies and the Township of Malahide installed transient pressure monitors at various locations along the transmission main, to capture potentially harmful transient pressure surges. As discussed in Section 1, previous failures were attributed to pressure surges caused by the opening of downstream fire hydrants and the activation of the Vienna Booster Station, which is designed to maintain the pressure in Vienna between 45 and 70 psi (which is in the Bayham Distribution System). Pressure monitoring indicated that the average pressure in the PVC section is approximately 40 psi, with pressure increasing to 80 psi when downstream hydrants are open. The Board has attempted to reduce the impact of these pressure surges by installing a surge busting check valve at the V001 Metre Chamber upstream of the Vienna Booster Station; however, the pressure data shows that transients can still occur. Pressure data can be found attached to this report as Appendix A. As the AC section is significantly farther upstream from the hydrants and the booster station, pressure increases in this area are minimal.

- The pressure surge seen in Appendix A was caused by the Bayham Water Department slowly opening Hydrant #47 in Vienna, to simulate a transient. This was done without the Vienna Booster Station online, as the risk was too great. Were the hydrant to be opened in uncontrolled situations, such as fire

protection, the magnitude of the transient would significantly increase, putting significant physical strain on the PVC pipe.

- In the short term, the transmission main should be operated with significant effort put towards maintaining a consistent operating pressure and limiting pressure surges. Previous PVC failures have most likely occurred due to pressure surges when operating hydrants, and although the check valve installed in 2022 is intended to mitigate this, pressure spikes were still recorded during the monitoring period.
- Pure Technologies recommends that to reduce the environmental risk of the AC pipe section, the Board obtain an estimate for adding a second pipe be supported by the Bridge, creating a redundancy in this critical area.
