JOINT AGENDA

AYLMER AREA SECONDARY WATER SUPPLY SYSTEM PORT BURWELL AREA SECONDARY WATER SUPPLY SYSTEM

REPORT NO.: PBASWSS-23-10
DATE: September 6, 2023
ATTACHMENT: Landmark Municipal Services - Port Burwell Water Tower Remote Inspection and Report, Corrosion Services Cathodic Protection Survey
SUBJECT: **Summary of Port Burwell Water Tower Inspection**

**Township of Malahide
Port Burwell Multi-Legged Tank
Remote Inspection and Report
May 2, 2023**

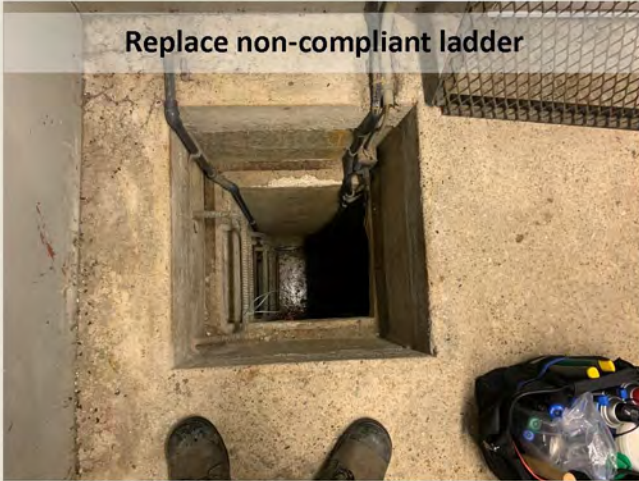
27

Replace non-compliant ladder

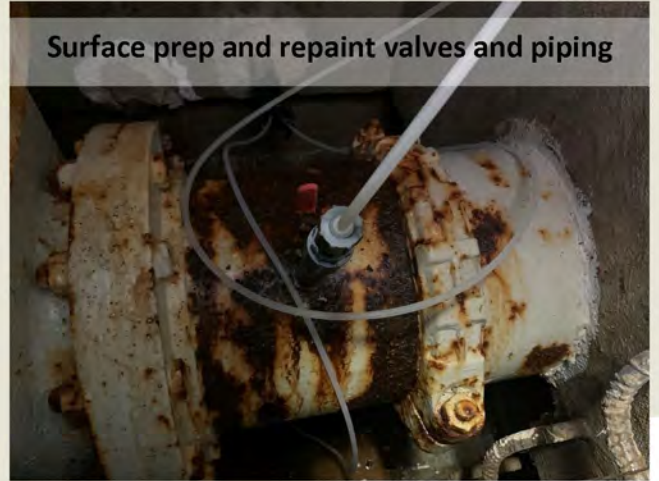
28

Surface prep and repaint valves and piping

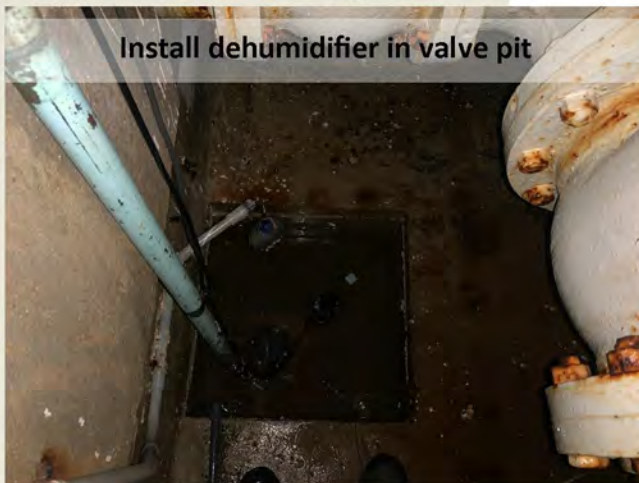
31

Install dehumidifier in valve pit

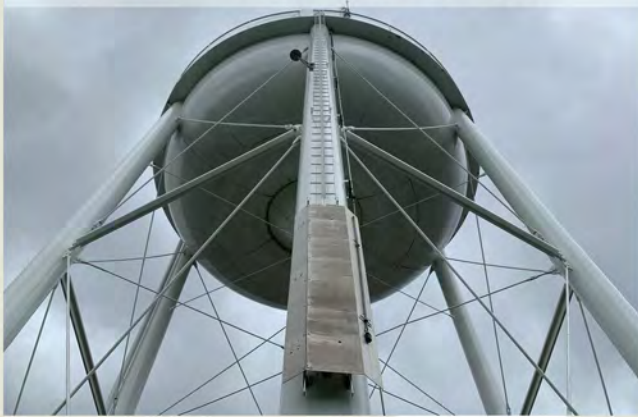
49

Install 'D' ring at bottom of ladder

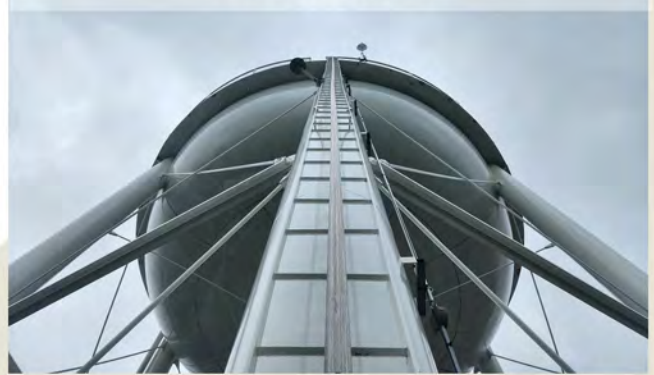
50

Replace non-compliant ladder and fall arrest system

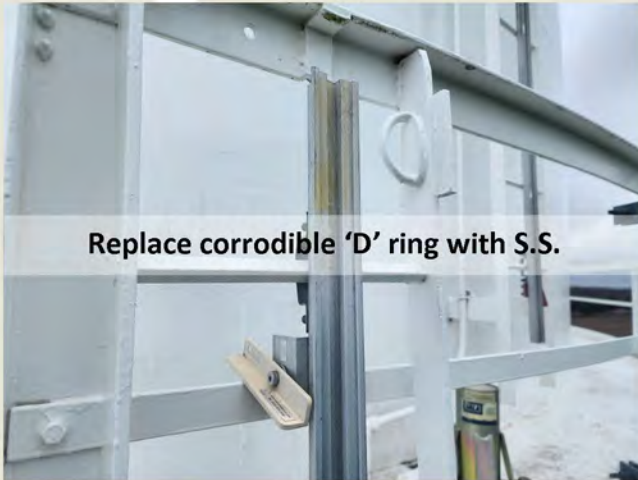
53

Replace corrodible 'D' ring with S.S.

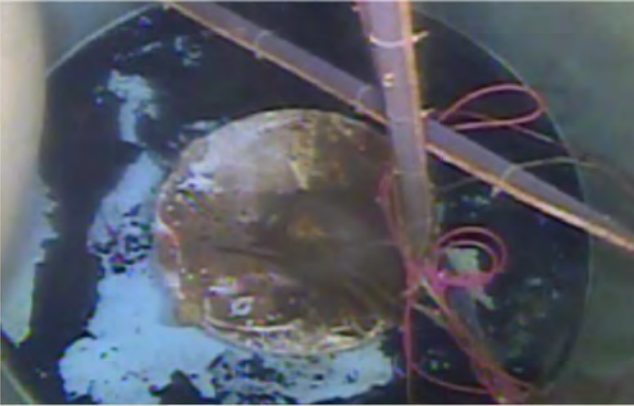
107

Repair cathodic protection system. Insufficient floats on lower anode

Hydrodynamic mixing system recommended
