JOINT AGENDA

AYLMER AREA SECONDARY WATER SUPPLY SYSTEM PORT BURWELL AREA SECONDARY WATER SUPPLY SYSTEM

REPORT NO.: PBASWSS-23-10
DATE: September 6, 2023
ATTACHMENT: Landmark Municipal Services - Port Burwell Water Tower Remote Inspection and Report, Corrosion Services Cathodic Protection Survey
SUBJECT: **Summary of Port Burwell Water Tower Inspection**

**Township of Malahide
Port Burwell Multi-Legged Tank
Remote Inspection and Report
May 2, 2023**

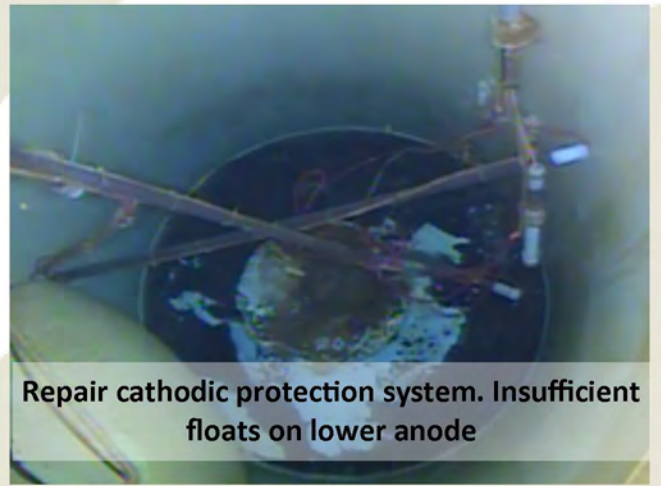
105

Repair cathodic protection system. Insufficient floats on lower anode

8. Remove and replace non-compliant rungs from catwalk manway to tank interior. (20 pcs).
*Pricing includes all interior & exterior coating repairs
9. Relocate hinges on roof hatch (handrail interferes with hatch opening)
10. Repair & test cathodic protection system
11. Design, supply and install Hydrodynamic mixing system

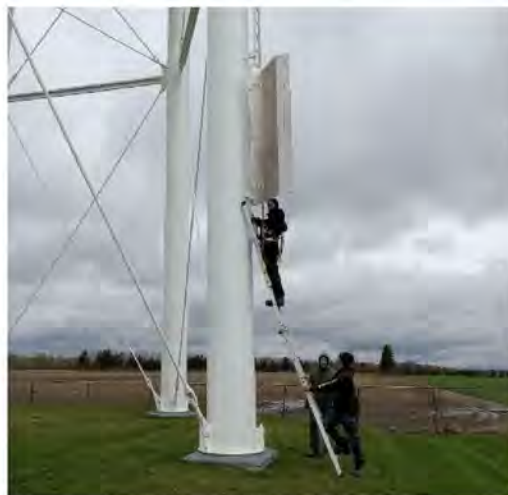
Picture - 1: Ladder Access To Tank

Note for future surveys where CSCL will require access to the top of the tank, a portable ladder and safety watch/rescue plan will be required.
